Subject: **Phase 2 Subsurface Investigation**
Cragin's Auto
NEC State and Pine Streets
Rutland, Vermont

PHASE 2 SUBSURFACE INVESTIGATION

Cragin's Auto
State and Pine Streets
Rutland, Vermont

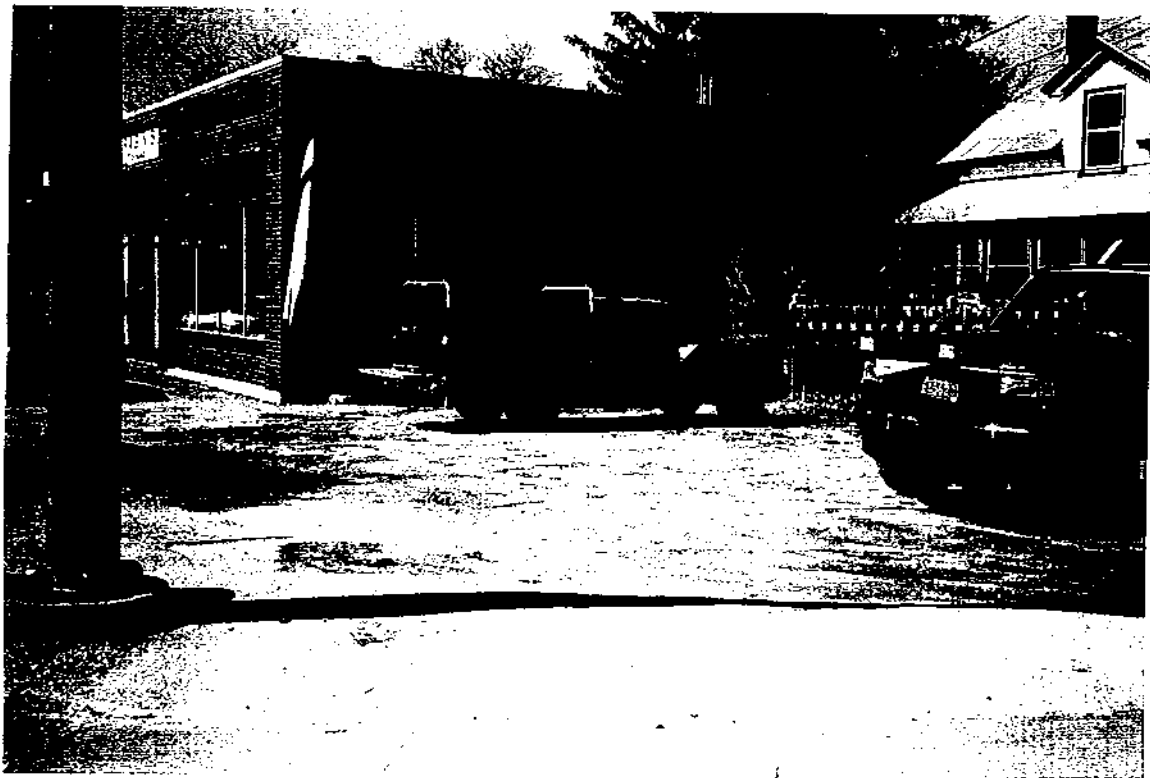
SUBJECT PROPERTY VIEWED TO THE WEST-NORTHWEST

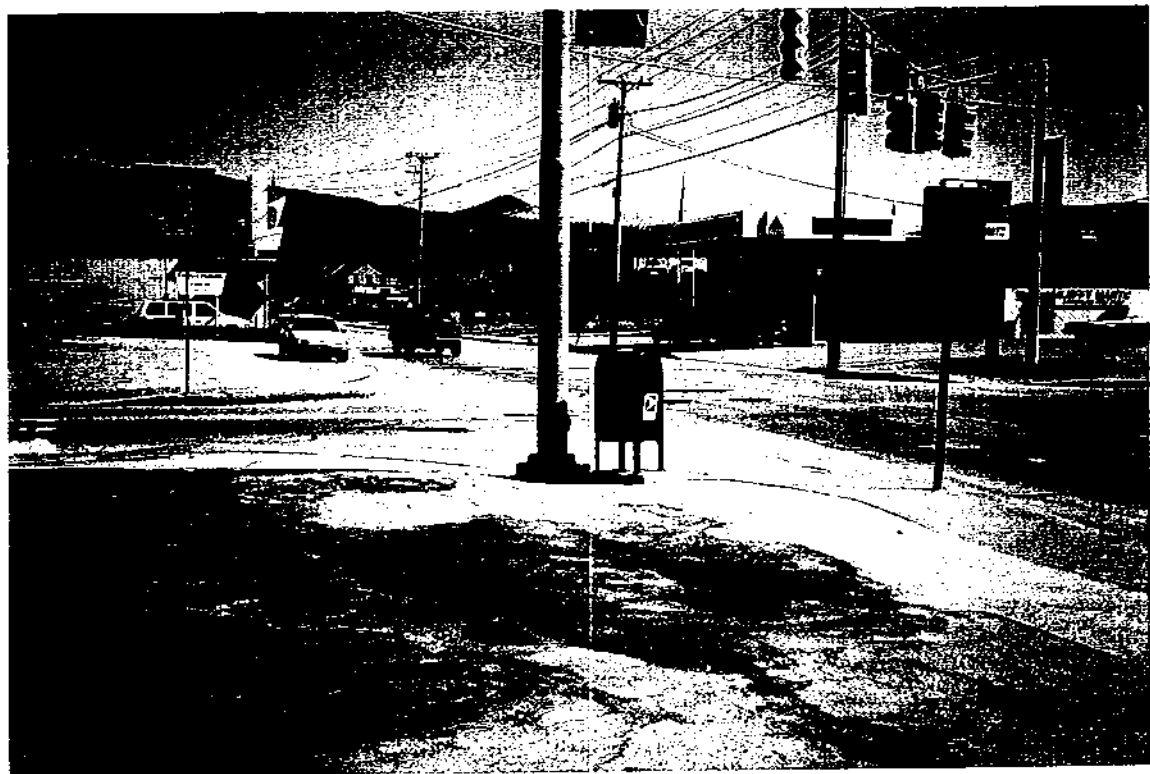
A Jiffy Mart gas station and convenience store is located diagonally across the intersection to the southeast from the property. Extensive groundwater contamination was detected at the Jiffy Mart site (DEC Site # 90-0643), including free product in two of the wells. A soil vapor extraction system was installed and remediation is ongoing.

LOOKING SOUTHEAST TOWARD THE JIFFY MART PROPERTY

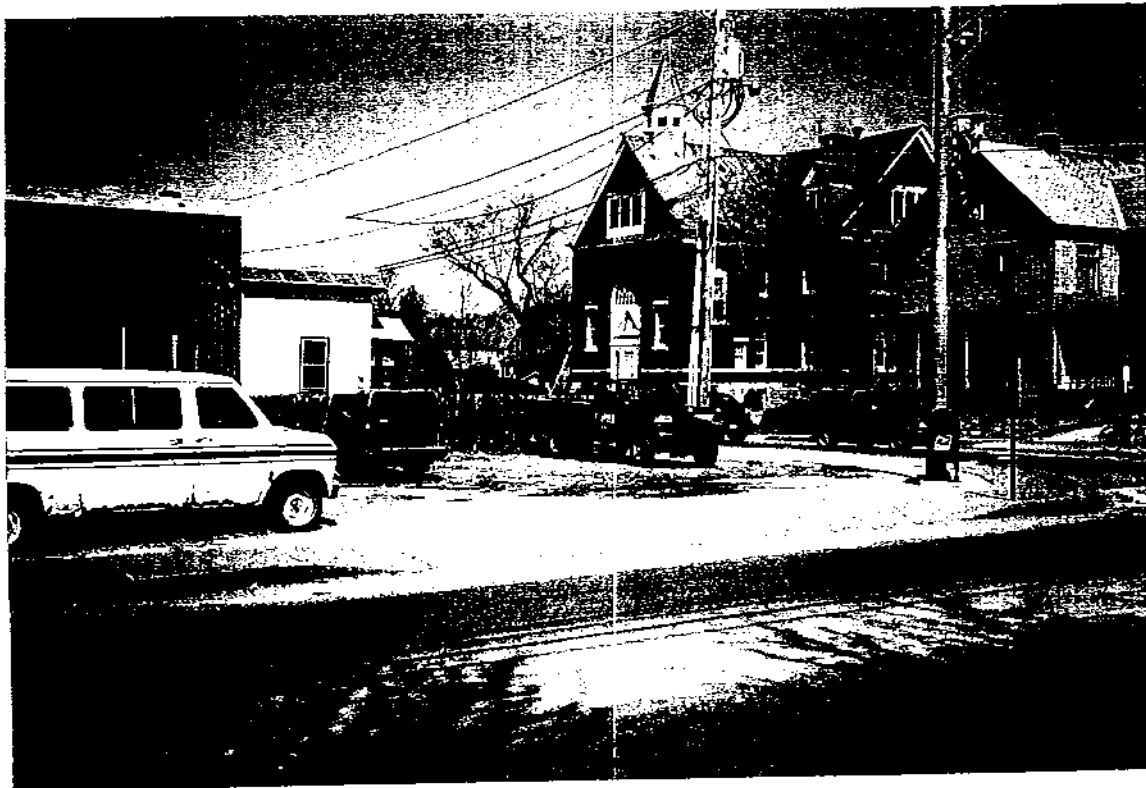
SUBJECT PROPERTY VIEWED TO THE NORTHEAST, ACROSS STATE ST

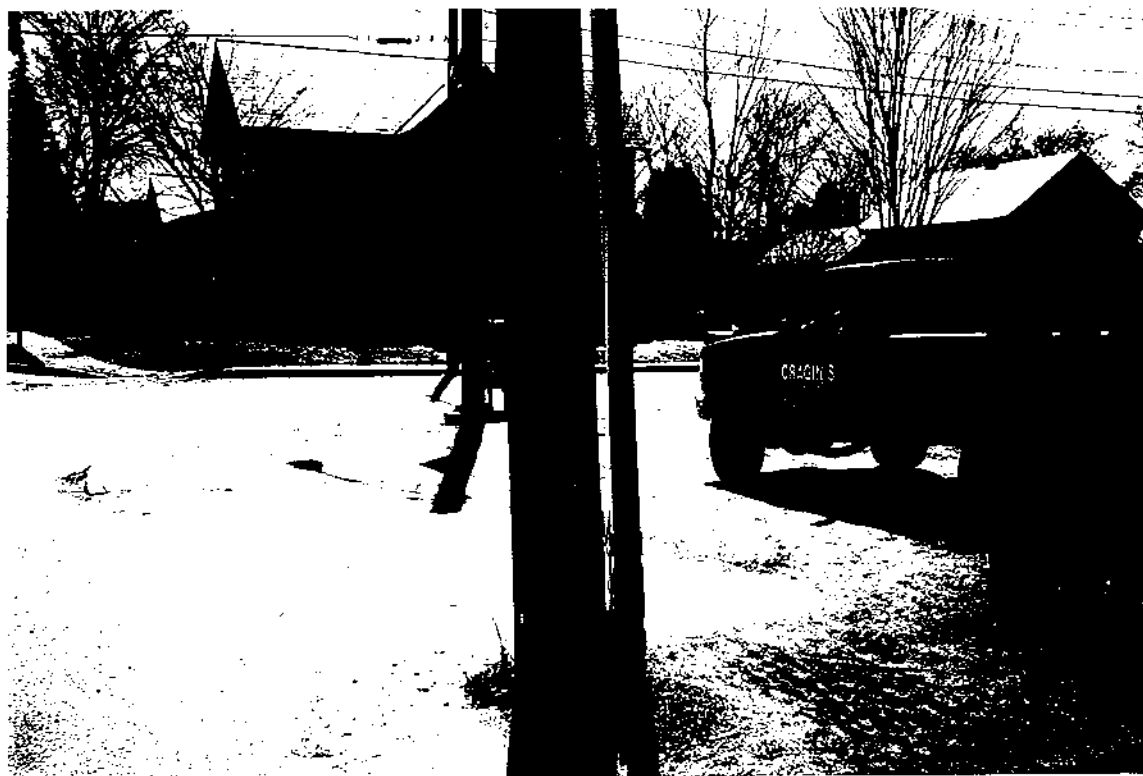
LOOKING SOUTH ALONG THE EASTERN BORDER OF THE SITE

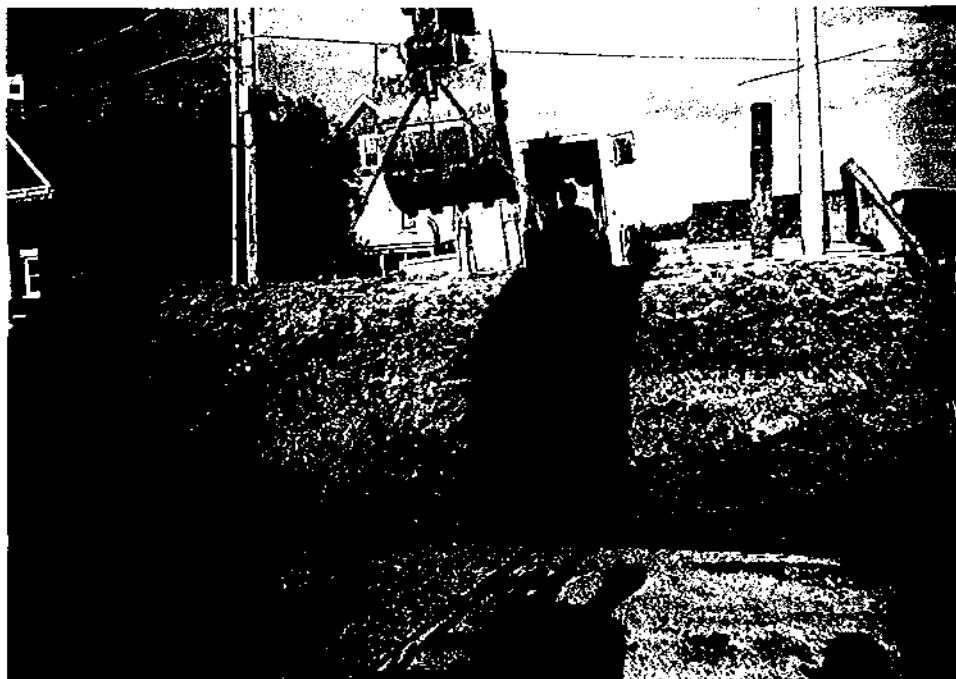
UST 4

UST #4 was removed and was poor condition, with severe rust and pitting and several holes. A total of six soil samples were collected. PID readings were between 0 and 110 ppm, and were collected at depths of 4 to 12 feet below grade.

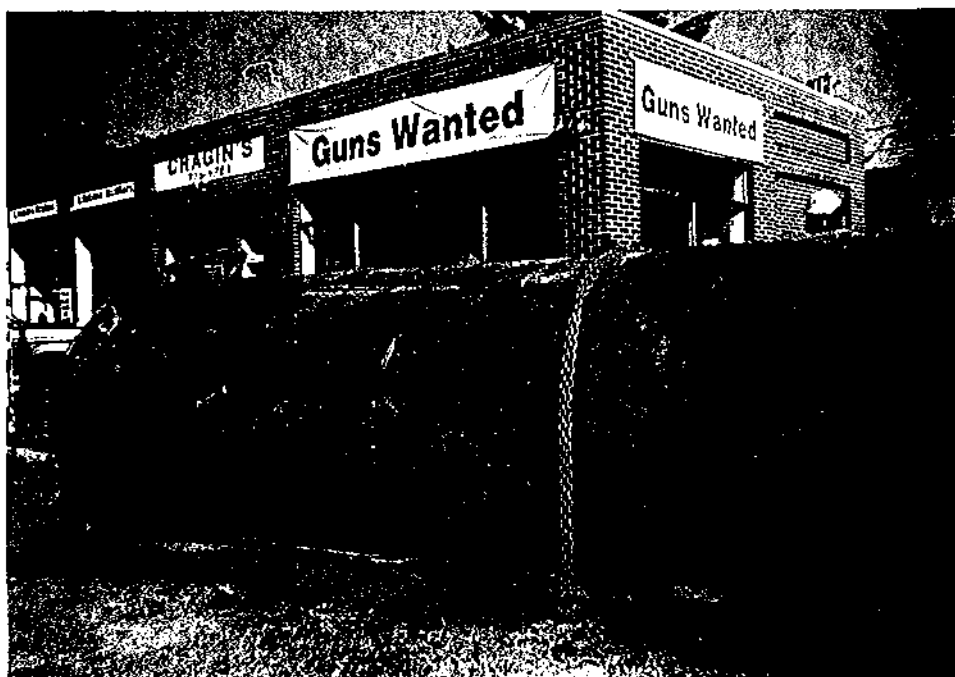
UST 5

UST #5 was removed and was poor condition, with severe rust and pitting and several holes. A total of five soil samples were collected at depths of 9 to 11 feet below grade. PID readings were between 1 and 110 ppm.
